# High compressive stress, low cycle fatigue of a composite material.

SUBMITTED IN PARTIAL FULFILLMENT  
OF THE REQUIREMENTS FOR THE DEGREE OF  
NAVAL ENGINEER  
AND THE DEGREE OF  
MASTER OF SCIENCE IN NAVAL ARCHITECTURE  
AND MARINE ENGINEERING

AT THE  
MASSACHUSETTS INSTITUTE OF TECHNOLOGY

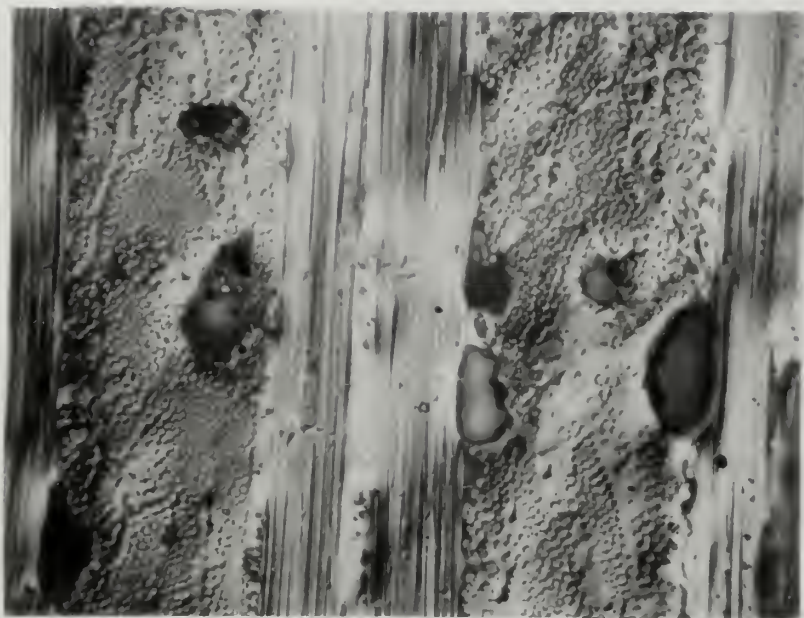
<u>Figure</u>	<u>Above Items Supported</u>	<u>Laminate</u>	<u>Face</u>	<u>Notable Items</u>
12	3	10	Perpendicular	This figure shows the same separation of in line and cross-ply in Laminate 10 as seen in Figure 9 for Laminate 11.
13		6	Parallel	Compare the excessive void content in Laminate 6 to the smaller void content in Laminates 11 and 10 shown in Figures 5 and 10 respectively.
14		11	Parallel	This photograph shows the normal appearance of the sectioned specimen after extensive cycling. There is generally little damage visible. The damage shown in Figures 5, 6, and 7 is generally not extensive.
15	4	11	In Line	This figure shows the transverse surface crack discussed above.
16	1,2,3	11	Parallel	This figure shows a failure. Note the sheared fibers and the separation of the in line and cross-ply at the left of the picture.

Figure 13  
Laminate #6  
Reference  
120X  
Parallel Face

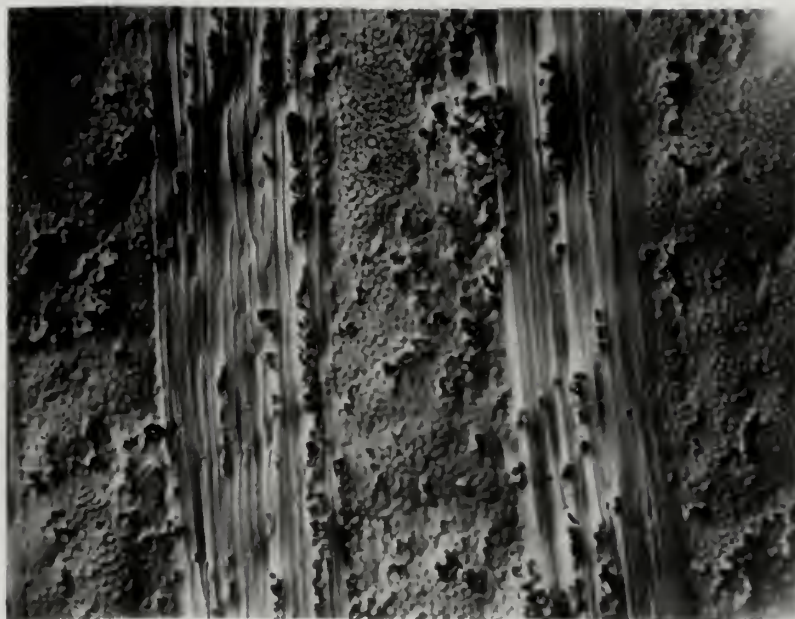
Figure 14  
#11BK  
70,000 psi  
11 Cycles  
No Failure  
120X  
Parallel Face  
Load Direction  
is Vertical

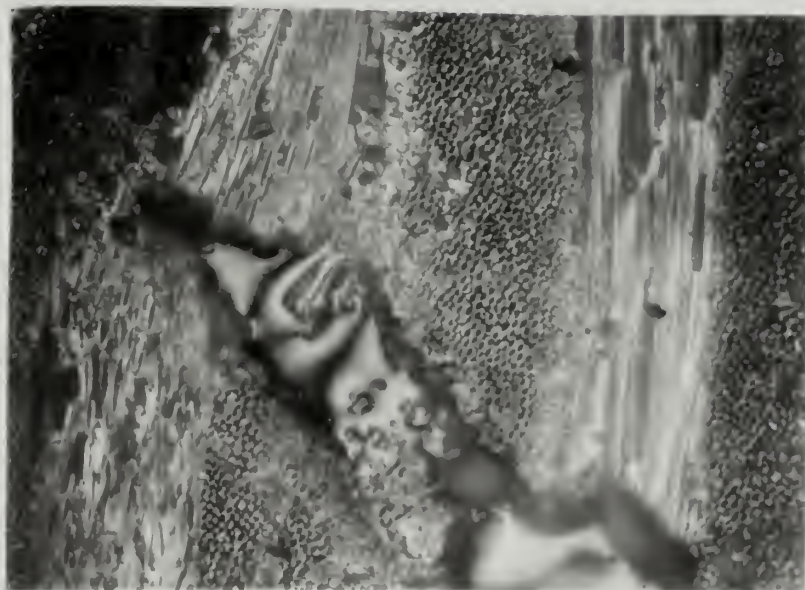
Load Direction

is Vertical

Figure 17. 12-30-I, 52,400 psi, 2 cycles, failure, 120X, parallel face, load direction is vertical, misaligned fibers on left.

Figure 4 shows the sectioned specimen faces defined under the microscopic analysis section in this thesis. Figures 5 through 16 show failure or progressive damage as a result of the compressive fatigue testing of reference laminates 6, 10, and 11. Figures 17 through 21 show failure damage of the laminates with misaligned plies.

Figures 17 through 21 support the following observations concerning compressive fatigue failure in cross-ply laminates with misaligned plies.

The following guide is included to aid in interpreting Figures 17 through 21.

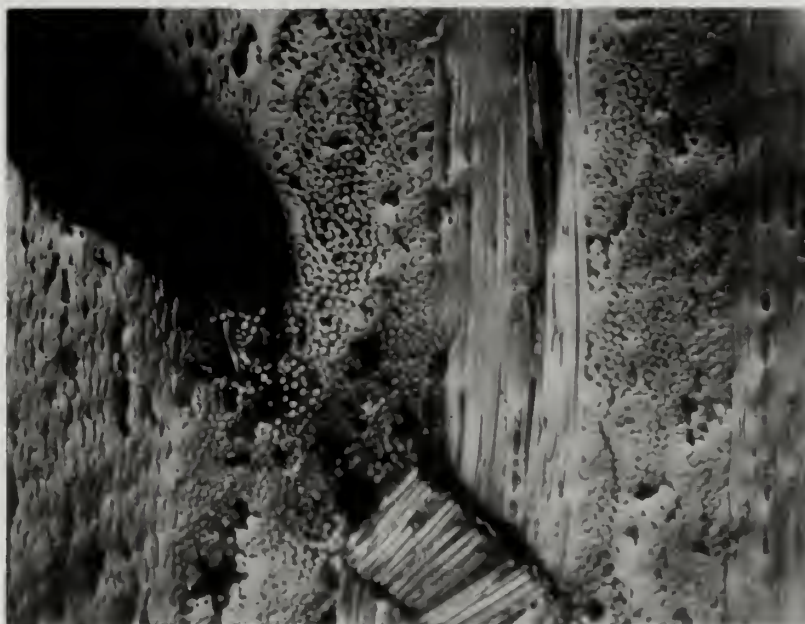
<u>Figure</u>	<u>Above Items Supported</u>	<u>Laminate</u>	<u>Face</u>	<u>Notable Items</u>
17,18	2	12-30	Parallel	The failure is exaggerated in the misaligned fibers.
19	3	12-30	Perpendicular	A separation occurs between the misaligned fibers and adjacent fibers in many cases. This damage was also noticeable within the misaligned plies.
20	1	9-45	45° plane	The fiber lengths shown are the plies misaligned by 45°. These fibers have failed with little other damage noticeable outside the misaligned plies.
21	2,3	13-15 12-30		The major damage occurs in the area of the misaligned fibers. The failure travels lengthwise along the misaligned fibers or the interface between the misaligned fibers and aligned fibers.

Figure 18. 12-30-J, 54,600 psi, 6 cycles, failure, 120X, parallel face, load direction is vertical, misaligned fibers on left.

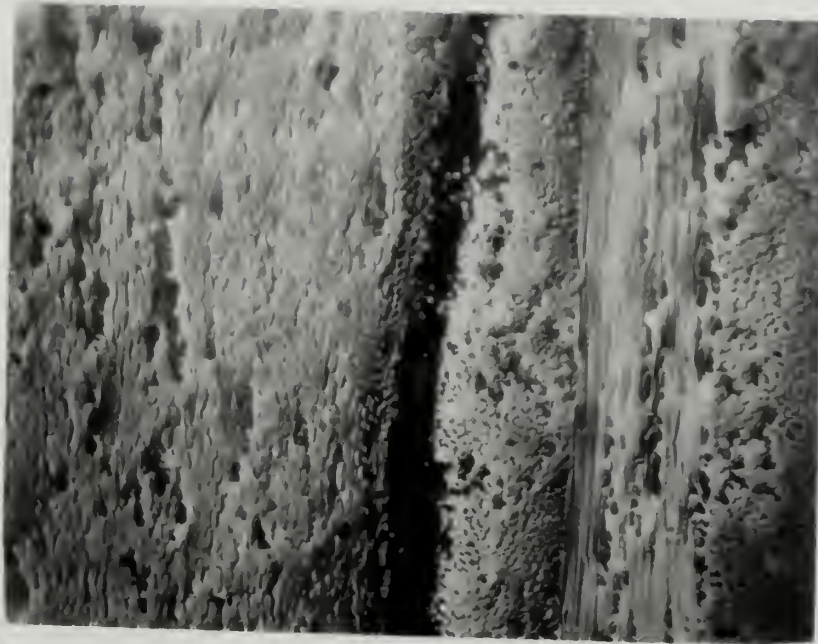
Figure 19. 12-30-I, 52,400 psi, 2 cycles, failure, 120X, perpendicular face, load direction is out of the page. Misaligned fibers on left.

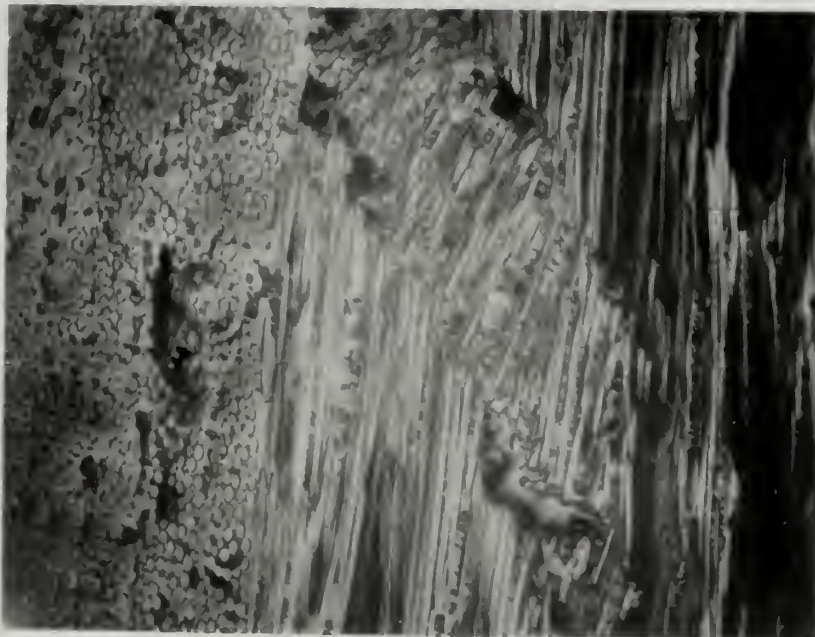
Figure 20. 9-45-E, 38,300 psi, 4 cycles, failure, 120X, face shown is  $45^\circ$  plane through center of specimen, broken fibers are  $45^\circ$  misaligned fibers, fiber ends on left are vertical fibers in line with the load.

The proposed failure mechanism is consistent with the results obtained with the misaligned ply tests. The four adjacent layers of misaligned plies gives a large thickness without the lateral support of the cross-plyies. Consequently, one would expect the separation effects to be large in the misaligned plies. Also less resin support would have to be removed from the fibers in these plies in order to cause fiber shear and failure of the composite. Figure 20 supports this hypothesis.
